Wet Work: Space Center Boulevard Storm Sewer Reconstruction

**BY MICHAEL OSBORNE
AND SANAZ GHALAMBOR,
NUKOTE COATING SYSTEMS**

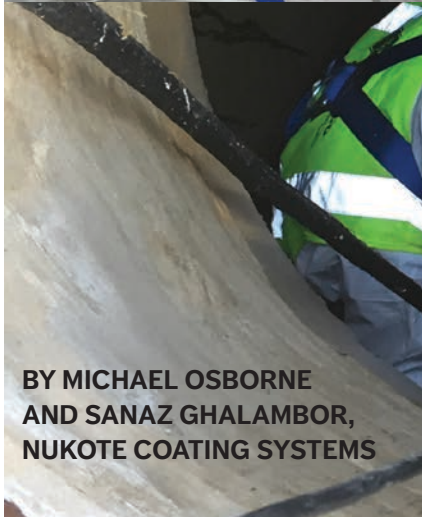
Fig. 1: Contractors prepare to go underground to perform rehabilitation on large-diameter concrete pipes. All photos courtesy of the authors.

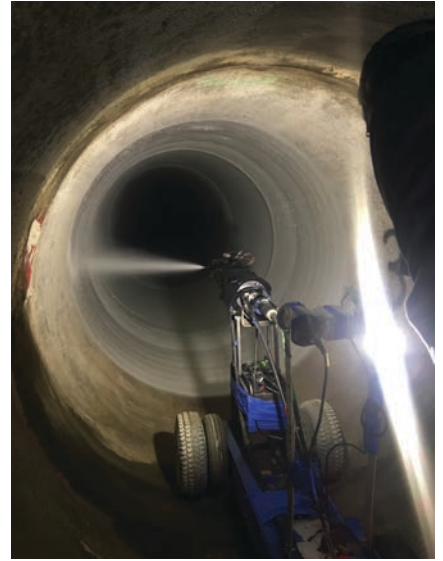
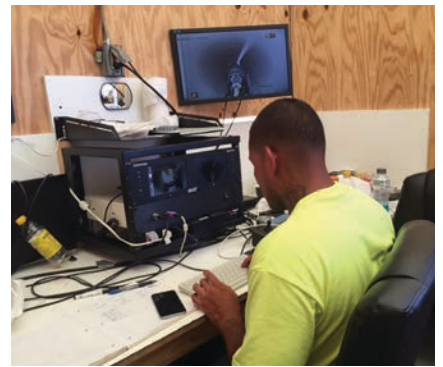
Fig. 2 (above): The lining system was applied to the pipe interiors with a 360-degree robotic spray system, controlled remotely on-site by contractor personnel.

The pure polyurea lining chosen provided a fast gel time, resistance to chemical exposure, was applicable with high moisture and high temperatures and had low volatile organic compound (VOC) content, among other features. The lining was spray-applied directly to the substrate using a plural-component proportioning robotic spray system at a dry film thickness of 240 mils to 480 mils, depending on the condition of the

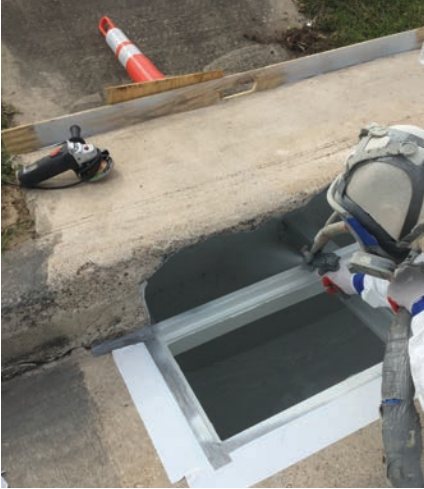
Fig. 3 (above): In addition to the pipe interiors, the contractors also spray-applied coatings to catch basins, manholes and other related structures.

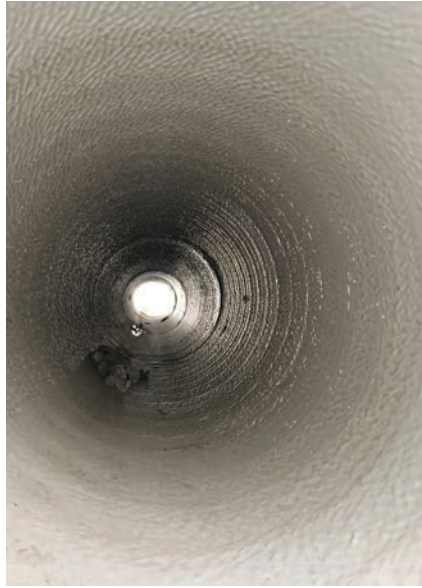
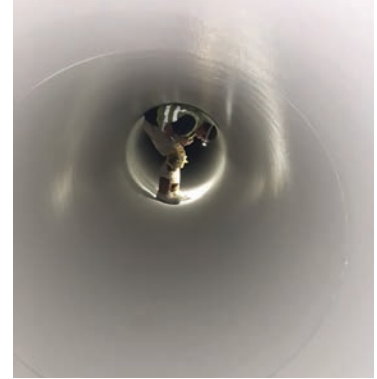
Fig. 4 (center and above): The finished, polyurea-lined pipeline was inspected and found to have rectified the historical problems with water intrusion and degradation at this site.

including; dewatering, injection of hydrophobic resins and surface cleaning, in advance of the robotic application of the liner. The installed liner successfully rectified the historical problems with the project.
