# **Project Profile**

Lining for Recovered Bitumen Tank Overflow Sump Primary & Secondary Containment Area

May 2015

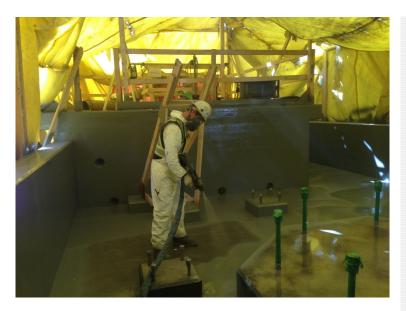
The client's Consultant specified a Membrane on concrete that was resistant to chemicals, yet flexible enough to move with concrete even in extreme cold conditions.

All new concrete was abrasive blasted and Nukote HLT applied to seal concrete. A 100% solids epoxy patching compound was used for bug holes. Fast set Nukote PolyPrime II was applied as primer to facilitate quick turnaround at low temperatures. Nukote ST Polyurea was immediately applied at a minimum thickness of 2 mm.
