Application

POTABLE WATER – STEEL TANKS

POLYUREA LINING ON STEEL

NUKOTE ST PURE POLYUREA

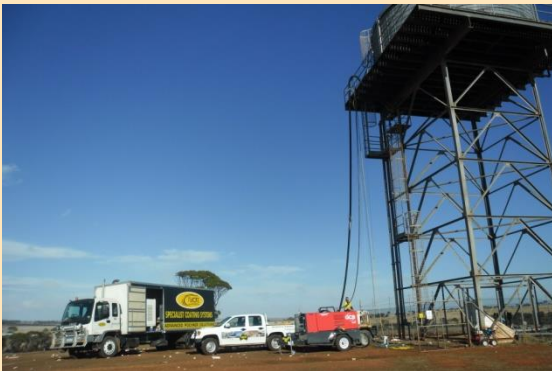
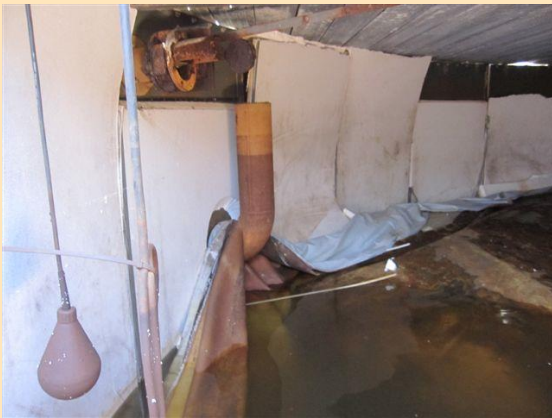
The failed PVC was removed then the tank pressure washed to remove sludge residue. Abrasive blasting then revealed the extent of the corrosion in the tank base.

Nukote ST pure polyurea was used to line the walls then flood the floor defects, seal all holes and reinforce the floor.

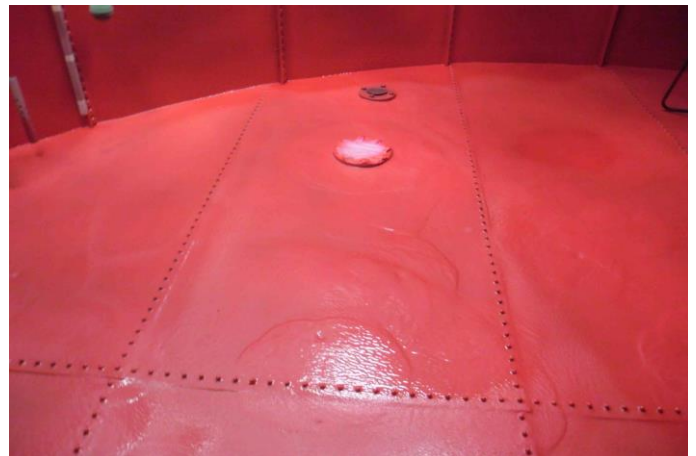
Completed Internal Liner
