Wet Work: Space Center Boulevard Storm Sewer Reconstruction

**BY MICHAEL OSBORNE
AND SANAZ GHALAMBOR,
NUKOTE COATING SYSTEMS**

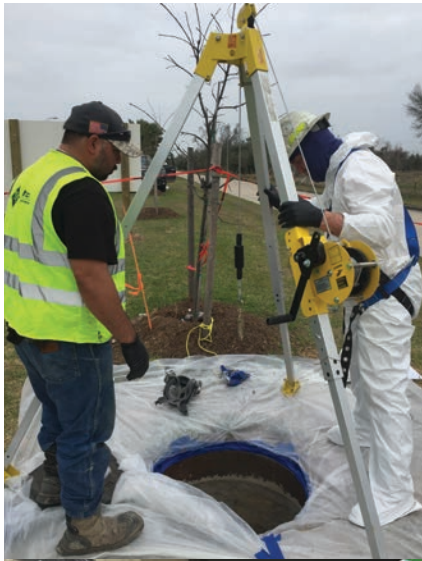
Fig. 1: Contractors prepare to go underground to perform rehabilitation on large-diameter concrete pipes. All photos courtesy of the authors.
