**Project:**

Small diameter spray-in-place pipe (SIPP)  
Rehabilitation for pressurized water pipe

**Client:**  
City of Boulder

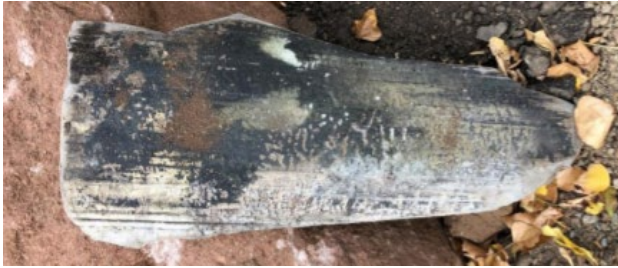
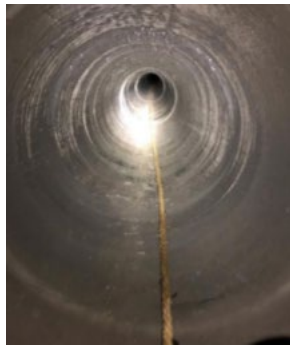
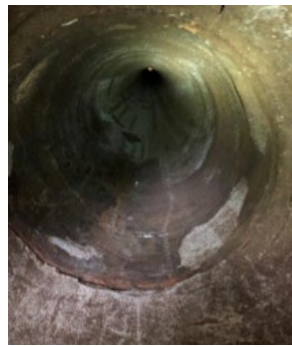
The old cement liner was delaminating, and large chunks were falling into the pipes. This was not an urgent repair, but the City decided to reline while other maintenance was being done and the lines were out of service. Nukote Aegis was selected as the repair method given considerations related to size, installation timeframe, and minimal liner thickness based on AWWA Class III.

Premera T7 LF

Nukote PP300 @ 200-250 mils
