Algeria Oman Fertilizer Plant Product Specification, Equipment, and Application

Nukote XT

Nukote XT+

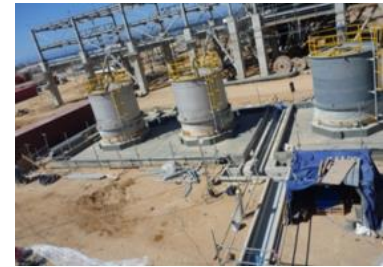
Nukote XT was applied in various locations within the project which included Primary Containment of Process Basins, Secondary Containment of Chemical Storage Bunds and Wastewater Process Tanks.

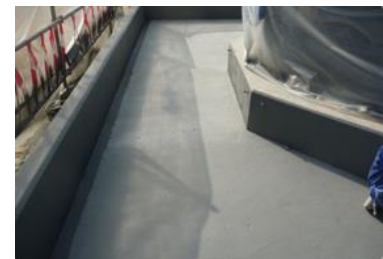
The largest application area was the chemical treatment and neutralization demi pits, which were completed in ten working days. The concrete substrate required skim coating of voids using Nukote epoxy filler composite system to rid the substrate of defects.

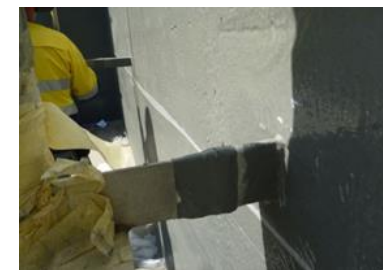
All three pits were fitted with a series of brackets to support process pipe structures. This was recognized as a critical area for the application works. A site-specific detail (pipe termination wrap) was designed and utilized to ensure that the coating was properly terminated at pipe brackets and other penetrations.

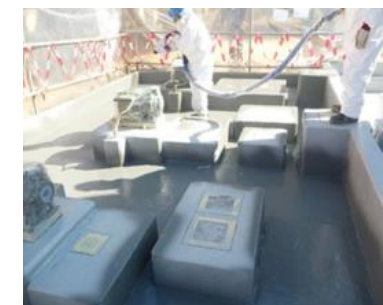
Two secondary containment bund areas were also coated, to ensure that Sulphuric Acid and Caustic Soda were properly contained should spills or leaks occur. This consisted of one bund area for caustic soda tanks and one bund area for sulphuric acid tanks.
