Waterproofing of the filter tank of a Water Treatment Facility of CASAN at Florianópolis - Brazil

Nov 2015

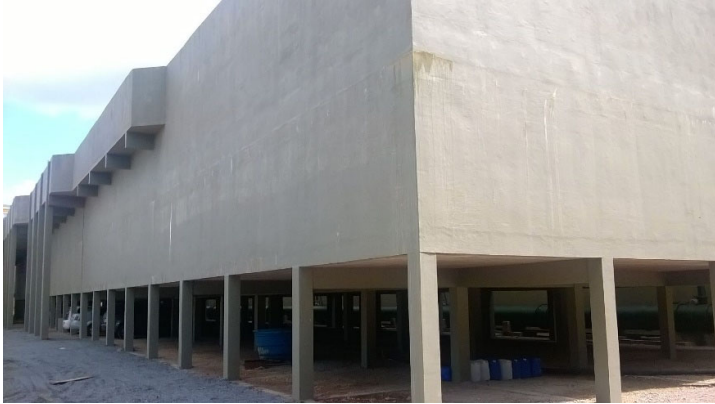
This water treatment facility was passing through a rebuilding process, which included the internal lining of the tanks as a long lasting waterproofing system.

Petranova, who is a company specialized on water facilities, chose Nukote ST for its high elongation and very low permeability and water absorption, with minimum installation time. The surface preparation included the complete removal of all unsound material and an extended surface patching, to assure the perfect bonding of the polyurea system to the substrate, what gives the customer a long durability and performance.

Nukote ST was applied at a minimum thickness of 2 mm over Nukote EP Prime BR, which was also used to prepare an epoxy mortar for the patch job.
